Manhole Inspection Summary

Manhole # S41C__036MH

Insp Date: **7/24/08 2:14 PM**

Location Address: **227-251 Silver Ct**

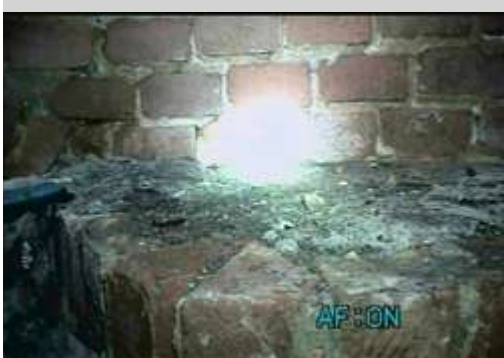
Misc

bench debris

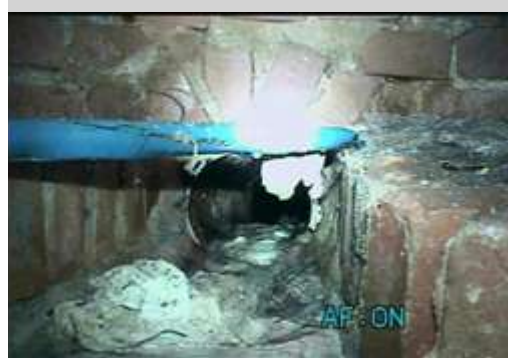
Misc

channel debris

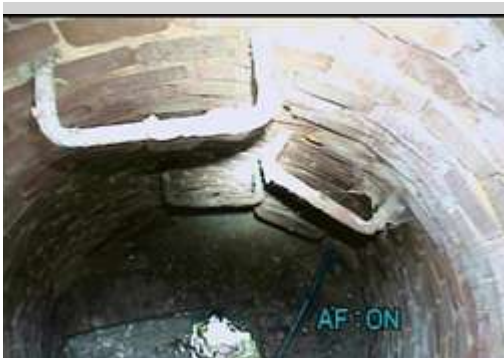
Defect 2

Steps Count: **4** Missing: **0** ☒ **Corroded**

steps

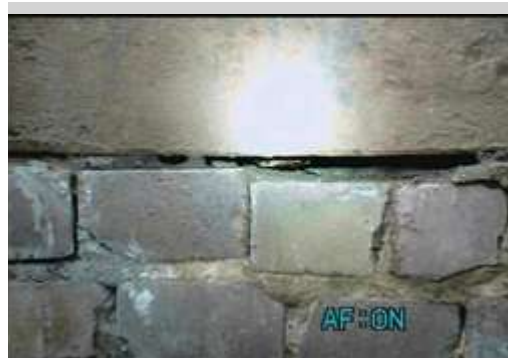
Defect 1

Condition: ☐ Sound ☐ Cracked ☐ Root Intrusion ☐ Loose Brick ☒ **Deteriorated**

chimney cond deteriorated

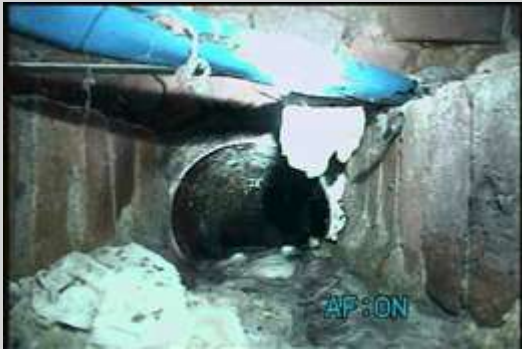
12 O'Clock Outflow

8 in. Circular Gravity Sewer
Pipe Out @ 12 O'Clock

Pipe Material: **Clay** ☐ Pipe Lined

Invert Depth: **8.50** (ft.) Flow Characteristics: **Fast**

Infiltration: **None** Pipe Seal Cond: **Unknown**

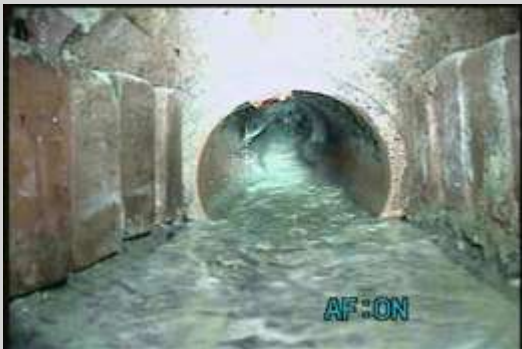
3 O'Clock Inflow

8 in. Circular Gravity Sewer
Pipe In @ 3 O'Clock

Pipe Material: **Clay** ☐ Pipe Lined

Invert Depth: **8.41** (ft.) Flow Characteristics: **Fast**

Infiltration: **None** Pipe Seal Cond: **Unknown**
